Building Conditions Investigations Report

Anna H. Rockwell Elementary School:
400 Whittlesey Drive
Bethel, CT

Mechanical and Electrical Systems
Existing Conditions Narrative

Anna H. Rockwell School
Bethel, Connecticut
June 27, 2011

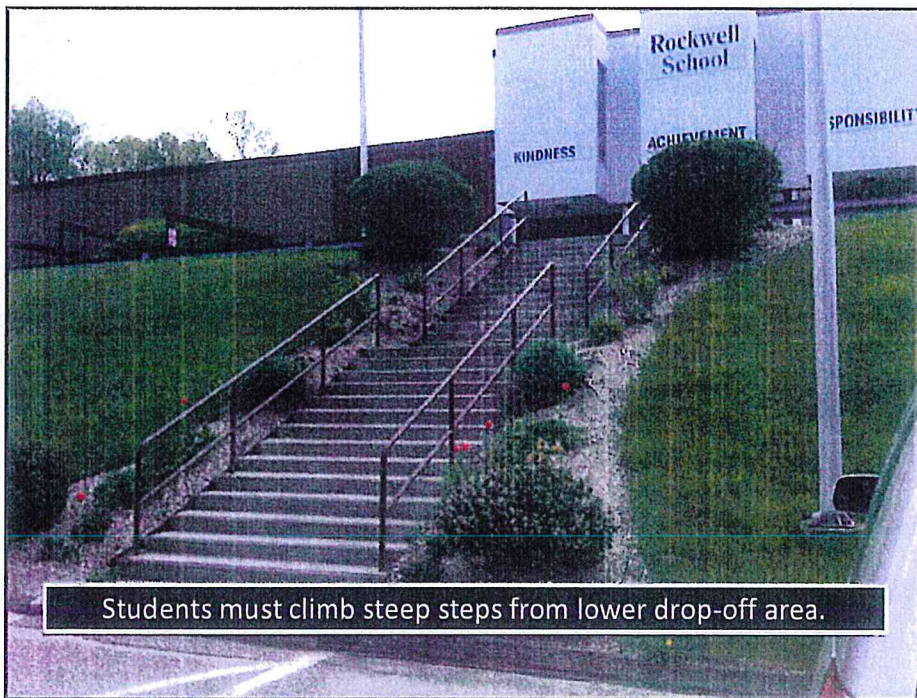
- Bus loading and drop-off drive in front (North side of building).
- Steep access drive, busses use upper level drive closer to the building; parents use lower level drive. Students must climb a long and steep set of stairs after being dropped off by private cars, to get to the front entrance.

Students must climb steep steps from lower drop-off area.

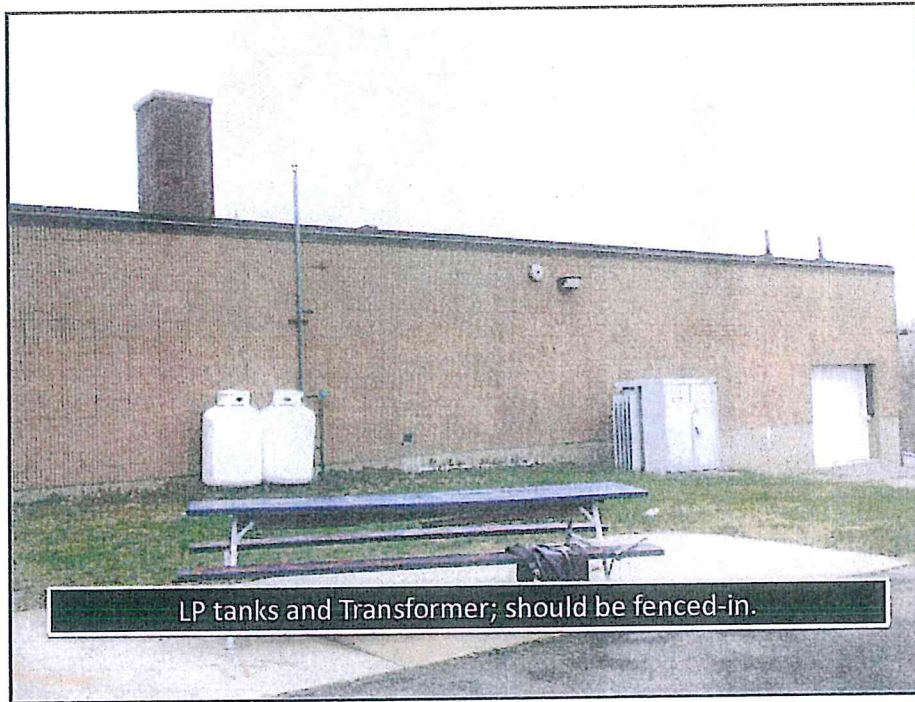
LP tanks and Transformer; should be fenced-in.

- a. There are existing 100lb propane tanks that serve the stove in the kitchen. These tanks are located on the exterior of the building. Additional protection, such as fencing should be provided.

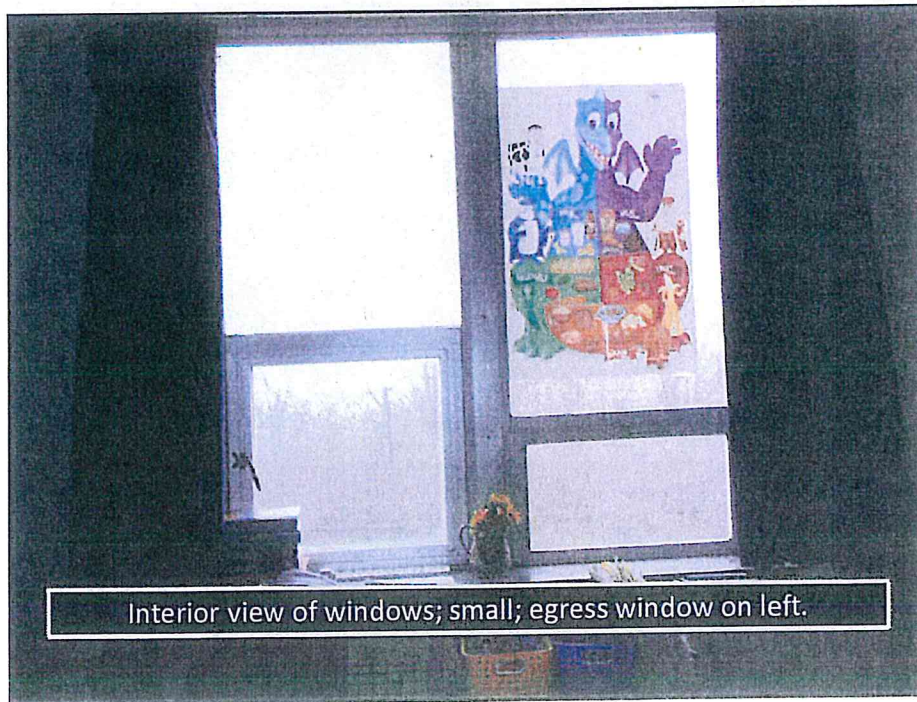
- *Windows:* Single pane aluminum-framed curtainwall window system. Operable portions of windows are small. Window size in general is small, providing limited daylighting to interior of building. Windows are a source of heat loss, and should be replaced. It appears that, at the time of original construction, it may have been necessary to modify the installed windows to remove one small 'hopper' style ventilation window in each classroom, and replace it with a slightly large swing-style operable window, for suitable emergency egress use. See photo.

Interior view of windows; small; egress window on left.

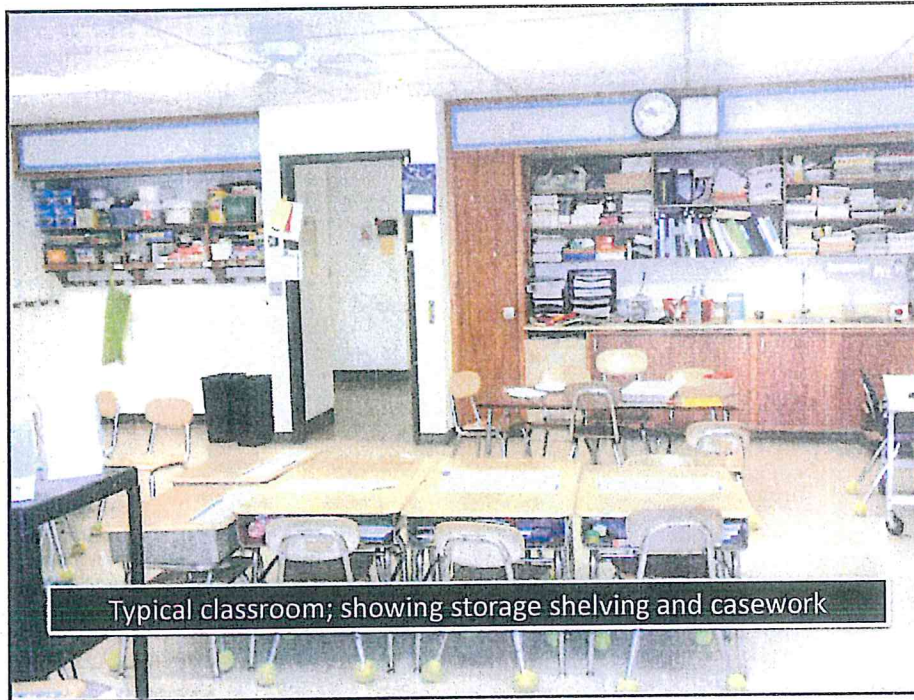
- Classroom casework is generally solid wood with original clear finish, in good functional condition, but poor visual condition. Classroom casework generally has plastic laminate counters, and non-accessible sinks and drinking fountains set into the counters.

Typical classroom; showing storage shelving and casework

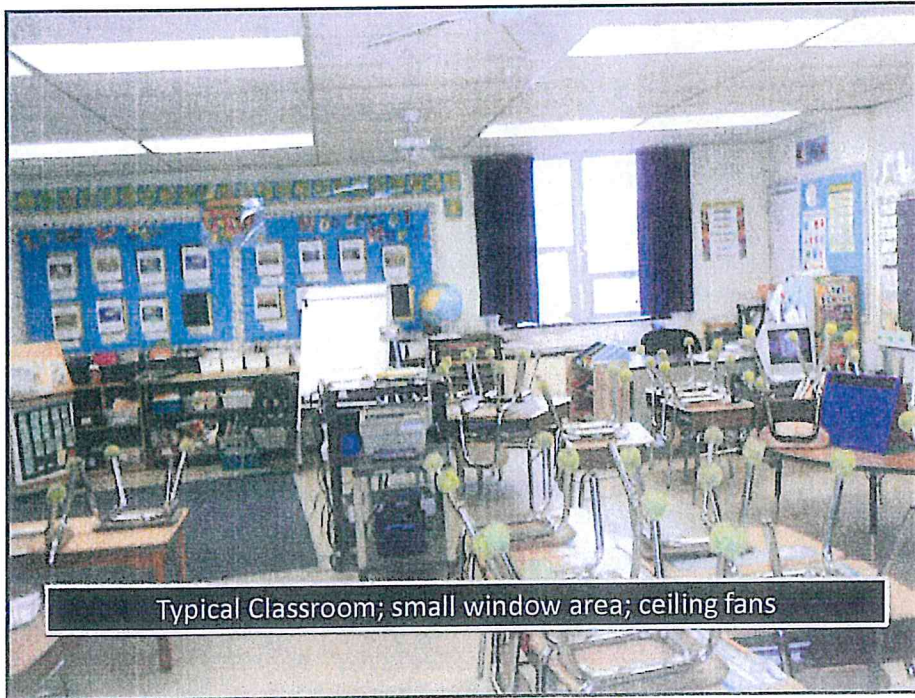
Typical Classroom; small window area; ceiling fans

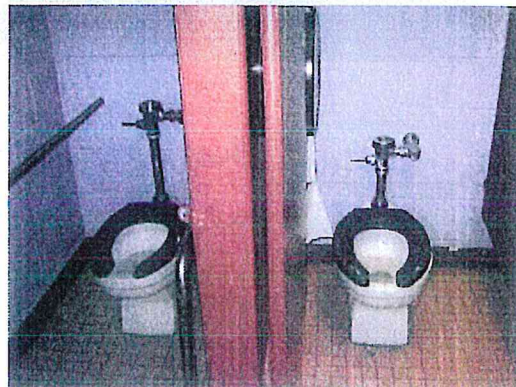
- Water closets are floor mounted; flush valve, vitreous china. These fixtures are non-water conserving type in fair condition.

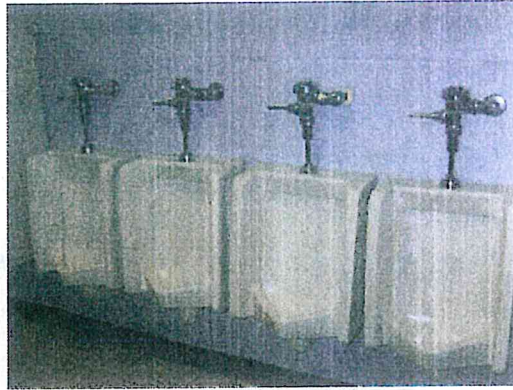
- Urinals are wall hung, vitreous china, with flush valves. These are non-water conserving type and in fair condition.

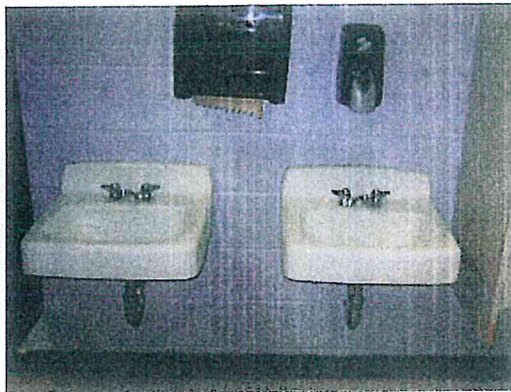
- Lavatories are wall hung vitreous china. Faucets are a combination of single lever handle and two lever handle faucets. The lavatories are in fair condition. The faucets and drains are non-ADA compliant.

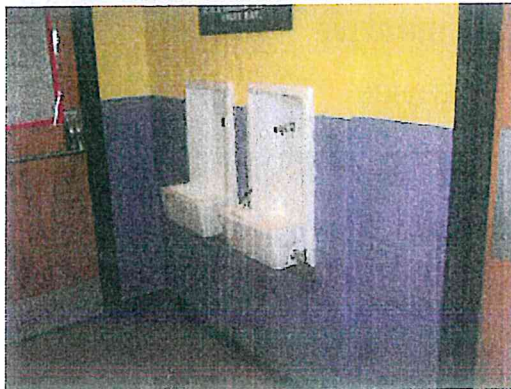
Drinking fountains are surface mounted stainless steel units or vitreous china, non-ADA compliant and in fair condition.

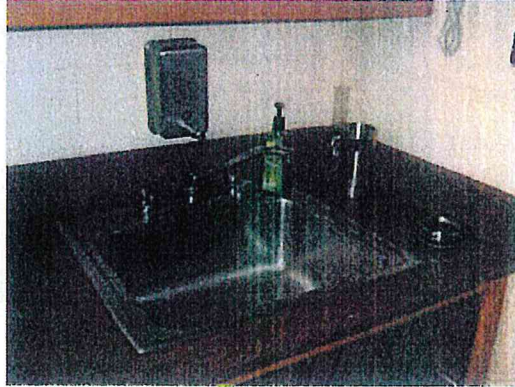
- Stainless steel sinks with kitchen type faucets are used in various locations, such as faculty work rooms, etc. These sinks are non-ADA compliant and in fair condition.

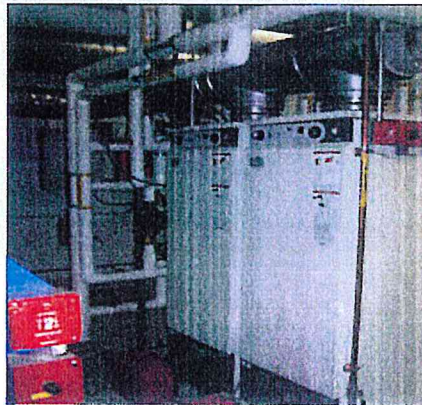
1. Existing Domestic Hot Water System: The Schools domestic hot water is generated by two Riello Delta Elite, Model F-47 oil fired domestic water heaters. The water heaters were installed in 2007 and are in very good condition.

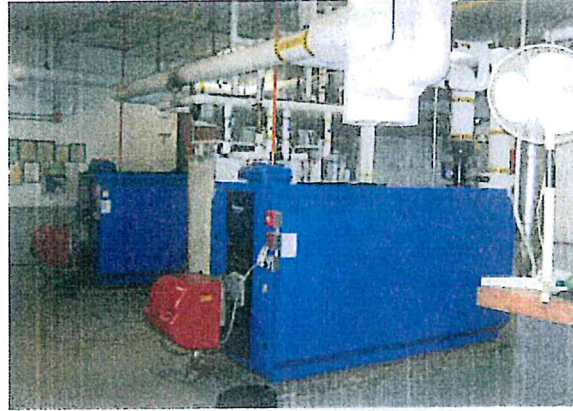
1. The existing building is heated by (2) oil fired hot water boilers. Boilers, pumps and hot water specialties in the boiler room were replaced in 2007. This equipment is in very good condition.

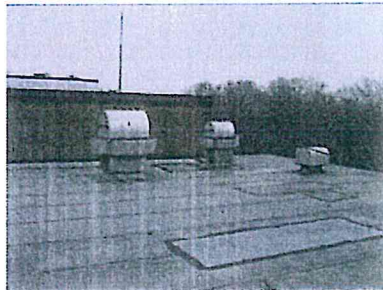
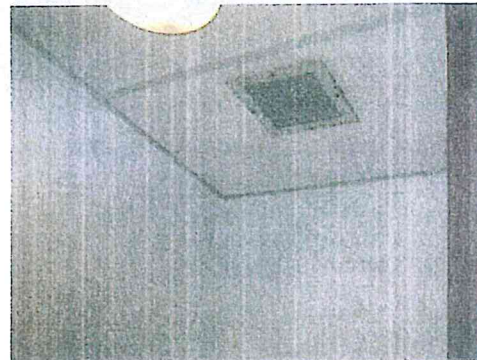
2. The present Heating and Ventilating systems consist of hot water finned tube radiation, hot water convectors, unit ventilators, window unit air conditioning units and exhaust systems. The mechanical equipment is located primarily in various indoor hallways, rooms and areas throughout the building. Exhaust fans air components are located on the roof. Air-handling units have hot water heating coils, filter sections, and exhaust fans. Exhaust ductwork is located above the ceilings.

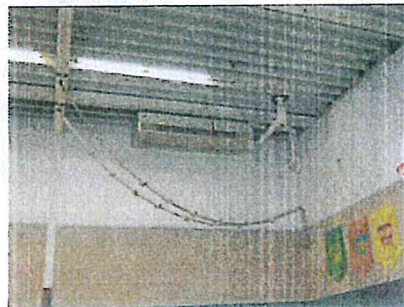
3. Gymnasium heating consists of air-handling units with hot water heating coils and roof mounted exhaust fans for ventilation.

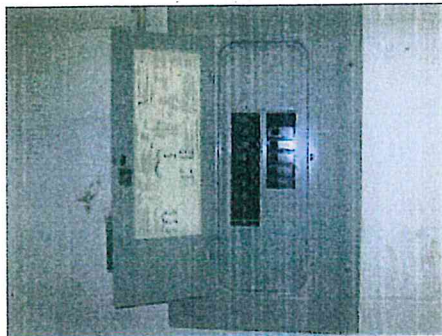
1. The building is served by a single electrical service rated 1,600 amperes, 208Y/120 volts, 3-phase, 4-wire. This service equipment consists of a utility company transformer, 1,600 amp main disconnect switch, distribution section and metering per utility company requirements. The service equipment is original to the building and is in fair condition.
2. There are a number of electrical panels located throughout the facility. These panelboards are original to the facility. The condition of these panelboards is fair. The majority of the panelboards do not have spare circuit breakers available for new circuits to be added, or have space to add new circuit breakers.

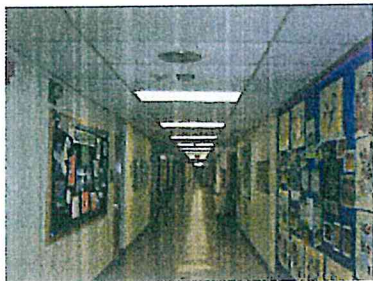
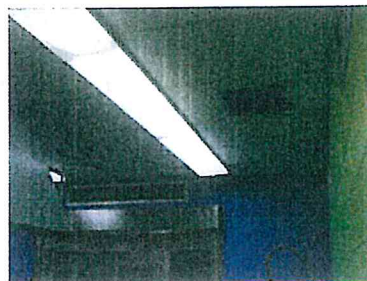
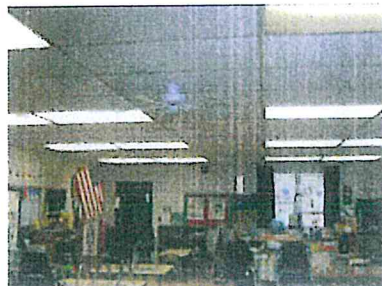
3. The lighting throughout the facility consists primarily of recessed mounted acrylic lensed fluorescent fixtures in the classrooms, hi-bay industrial fluorescent fixtures in the gymnasium, and surface mounted fluorescent fixtures in other areas. The lighting throughout the facility has been upgraded to T8 lamps and electronic ballasts in the last few years. Overall, the lighting is in fair to good condition and the light levels are within recommended levels.

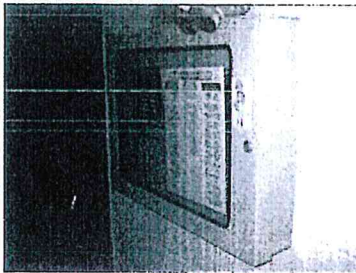
7. The existing paging/intercom system is a Dukane/Bogen system. This system is in poor condition and operation is not consistent.
8. The existing master clock system is a Simplex system. This system is not fully operational and individual battery operated clocks have been installed in many locations.
