Building Conditions Investigations Report

Ralph M. T. Johnson Elementary School:
500 Whittlesey Drive
Bethel, CT

Mechanical and Electrical Systems
Existing Conditions Narrative

Ralph M. T. Johnson School
Bethel, Connecticut
June 27, 2011

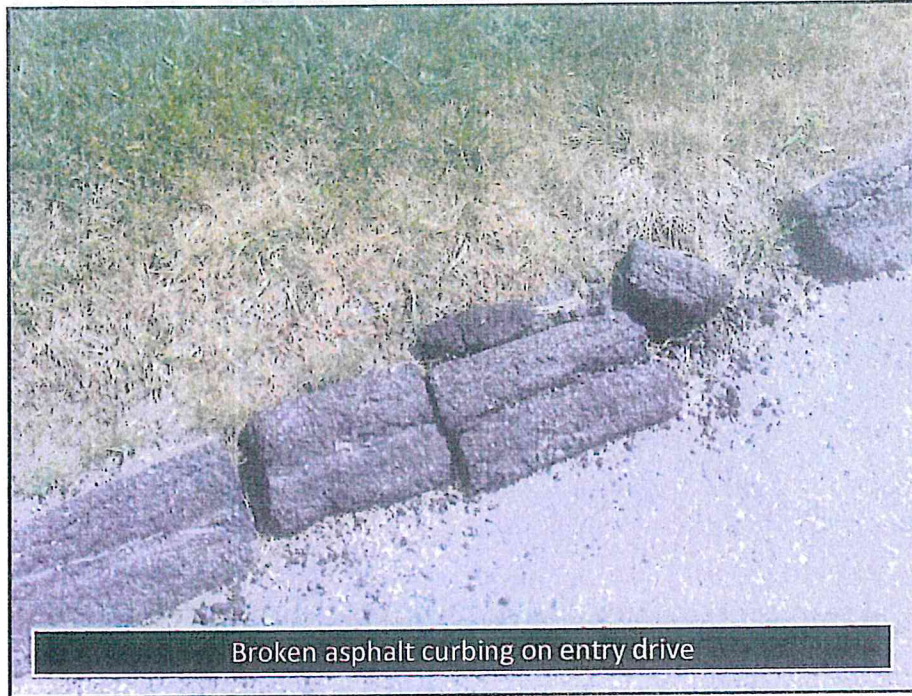
Broken asphalt curbing on entry drive

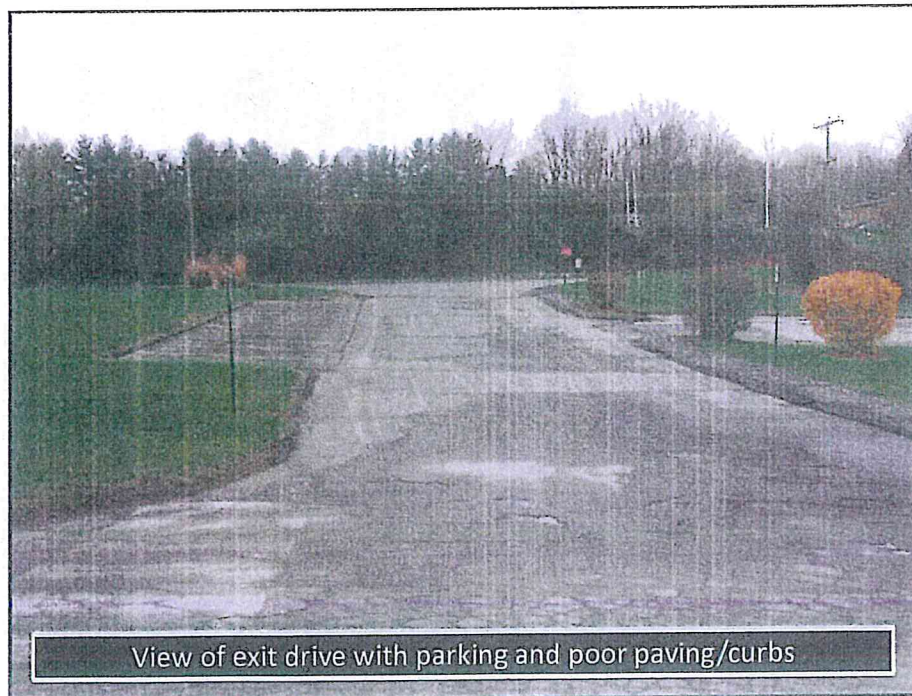
View of exit drive with parking and poor paving/curbs

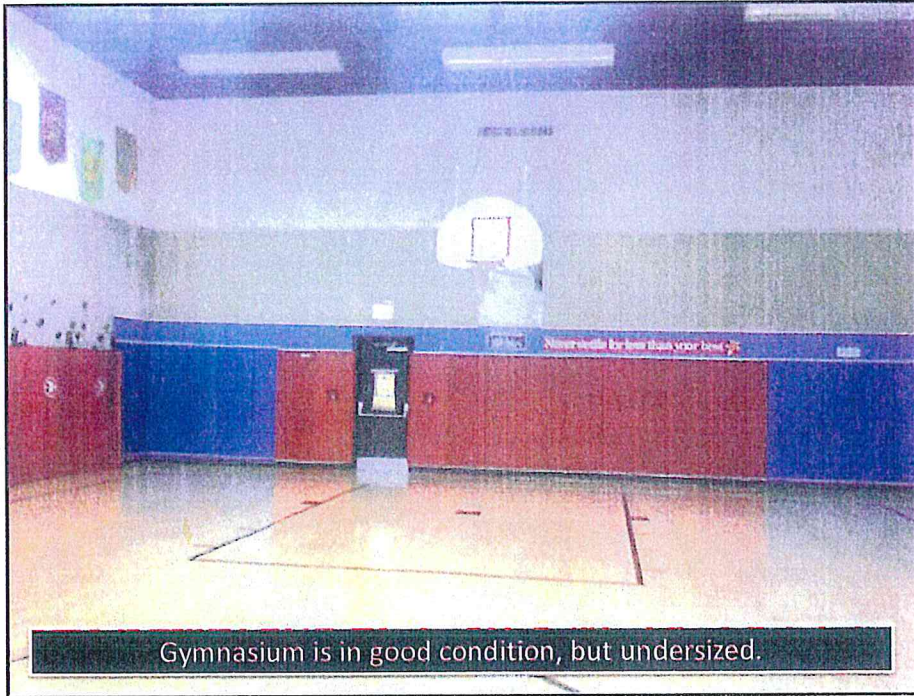
Gymnasium is in good condition, but undersized.

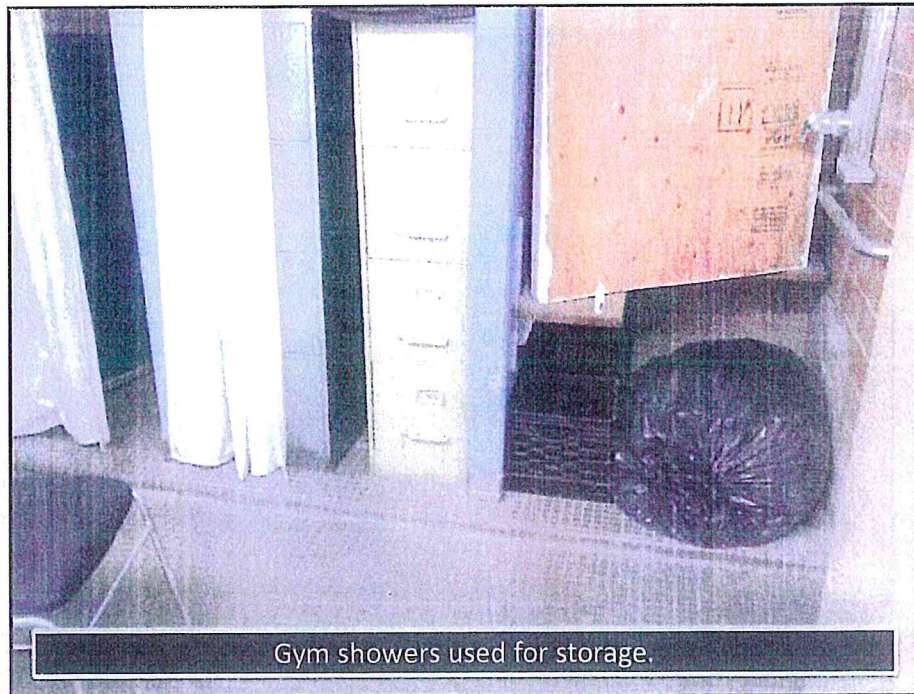
Gym showers used for storage.

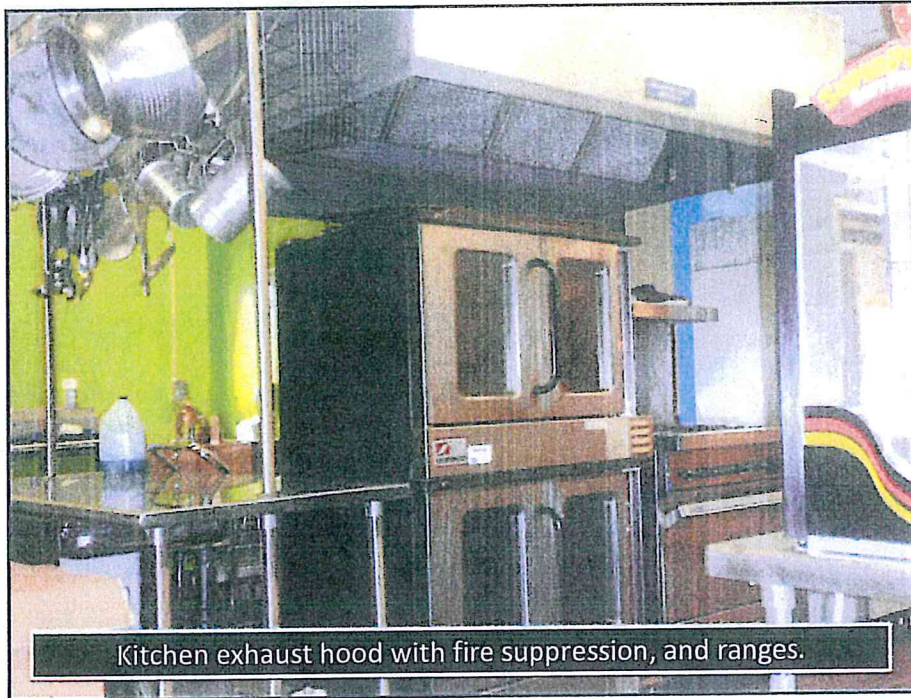
Kitchen exhaust hood with fire suppression, and ranges.

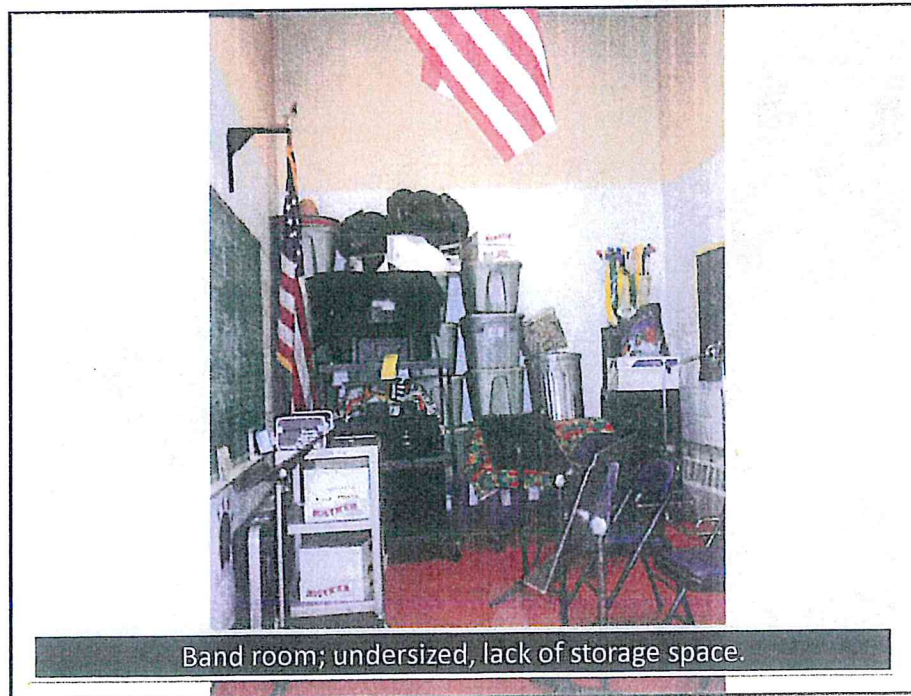
Band room; undersized, lack of storage space.

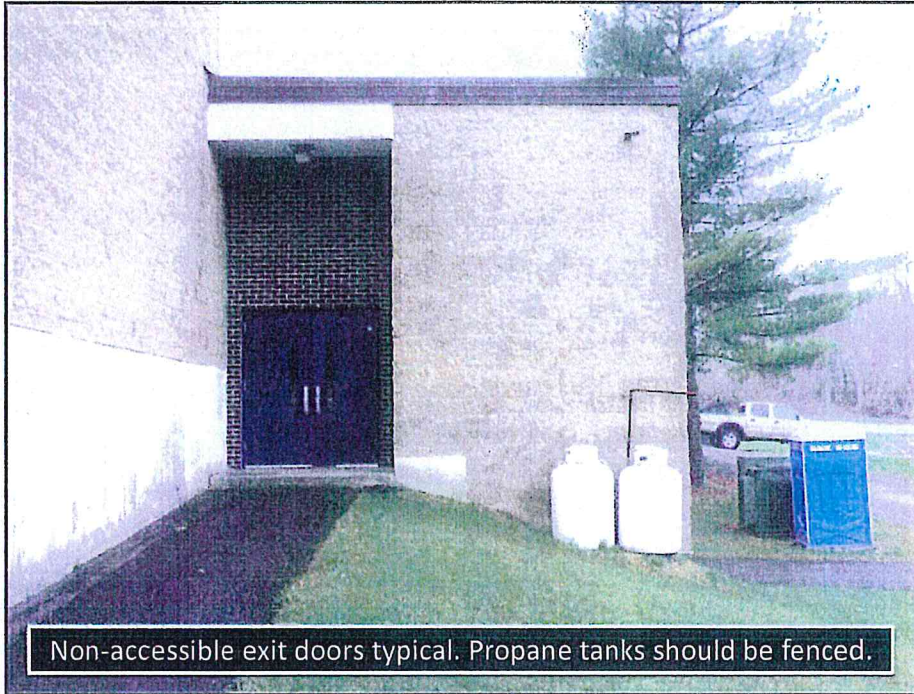
Non-accessible exit doors typical. Propane tanks should be fenced.

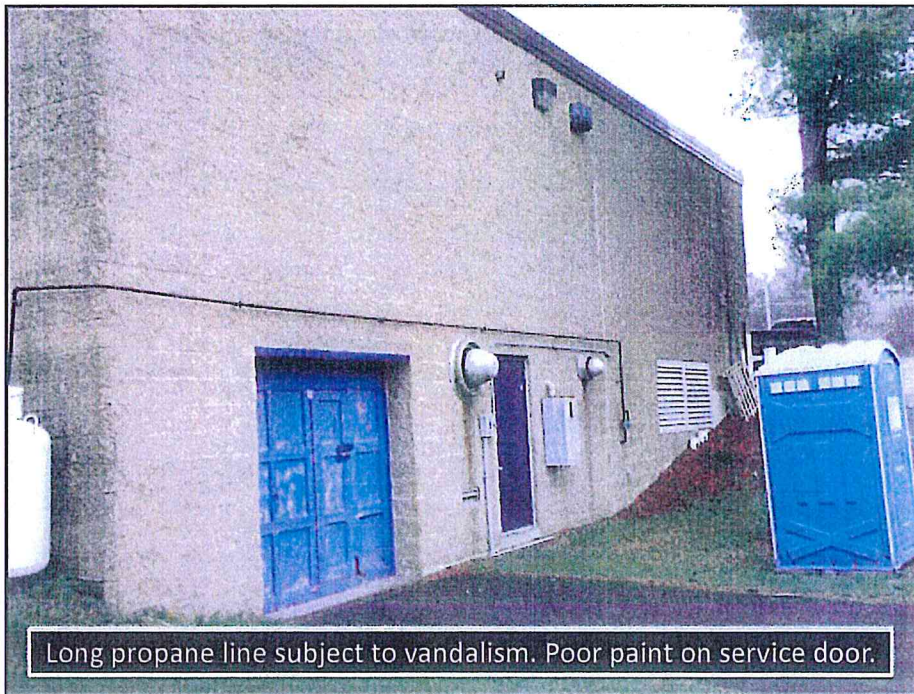
Long propane line subject to vandalism. Poor paint on service door.

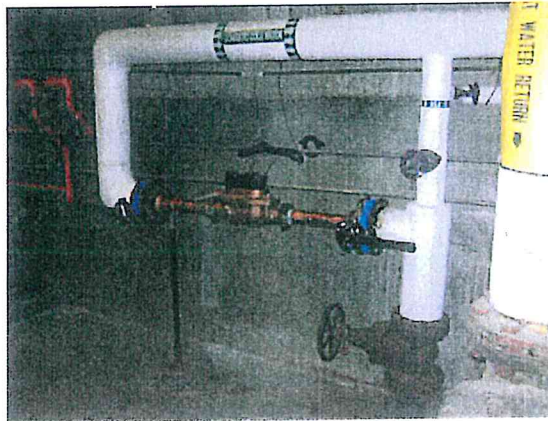
- a. Existing Domestic Water Service: The existing building is currently served by a 2 ½-inch domestic water service. The domestic water service equipment includes a 2 ½-inch water meter and isolation valves which have recently been replaced. This water service currently serves all of the Schools domestic water needs and has high pressure. The custodian has adjusted within the building to accommodate the building needs. The water distribution system is original to the building.

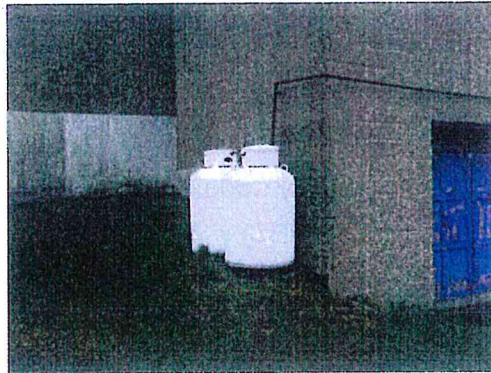
- a. There are existing 100lb propane tanks that serve the in the kitchen. These tanks are located on the exterior of the building. Additional protection, such as fencing, should be installed.

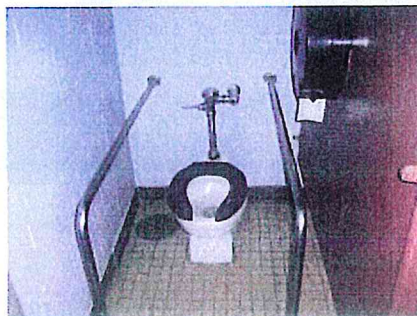
- Water closets are floor mounted; flush valve, vitreous china. These fixtures are non-water conserving type in fair condition. Most of these fixtures are non-ADA compliant, even with the rails installed.

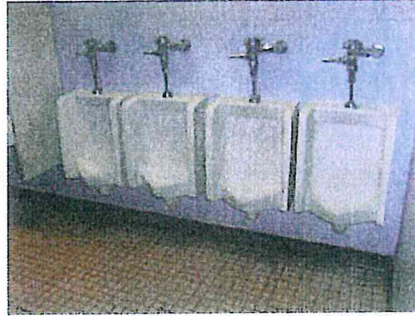
- Urinals are wall mounted, vitreous china, with flush valves. These fixtures are non-water conserving and non-ADA compliant. These fixtures are in fair condition.

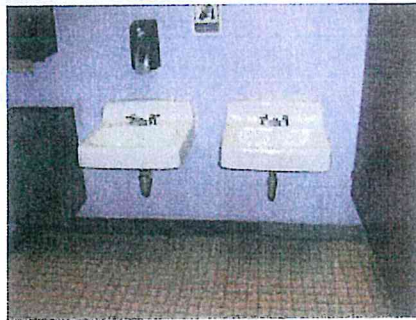
- Lavatories are wall hung vitreous china. Faucets are two lever handle faucets. The lavatories are in fair condition. The faucets and drains are non-ADA compliant.

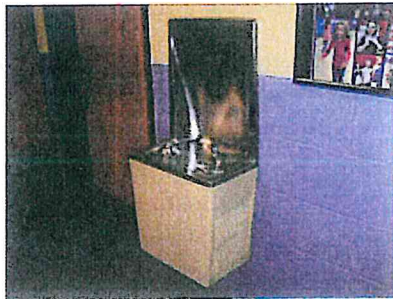
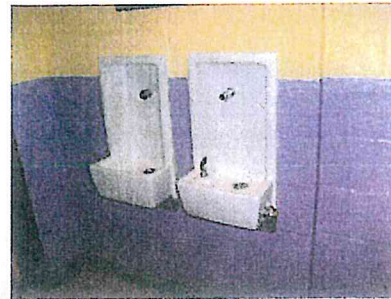
- Drinking fountains are surface mounted stainless steel units or vitreous china, non-ADA compliant. These fixtures are in fair condition.

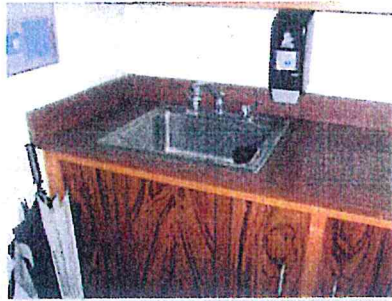
- Stainless steel sinks with kitchen type faucets are used in various locations, such as faculty work rooms, etc. These sinks are non-ADA compliant and in fair condition.
- Classroom sinks are stainless steel sink/bubbler combination units. These units are non-ADA compliant and in fair condition.

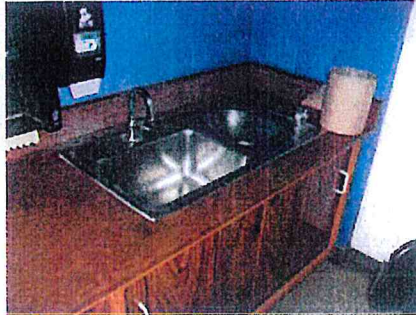
- Classroom sinks are stainless steel sink/bubbler combination units. These units are non-ADA compliant and in fair condition.

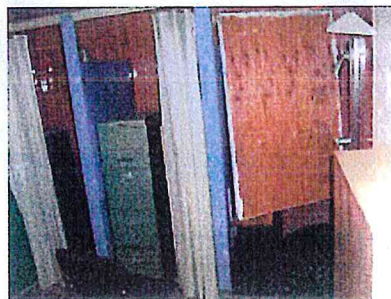
- There are showers at the school that are no longer in use. There are single stall showers and gang showers. These areas are currently used for storage.

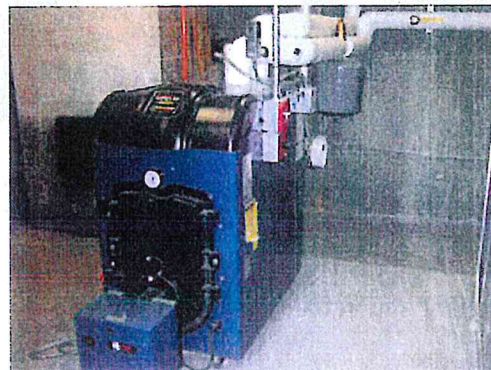
1. Existing Domestic Hot Water System: The Schools domestic hot water is generated by a single, Burnham Model MPO-1Q oil fired boiler. This equipment is recently installed and in very good condition.

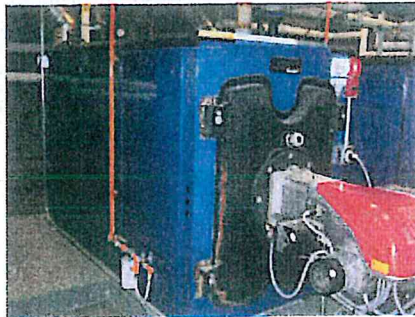
1. The existing building is heated by (2) Burnham MPC13C oil fired hot water boilers. Boilers, pumps and hot water specialties in the boiler room were replaced in 2011 and are in very good condition.

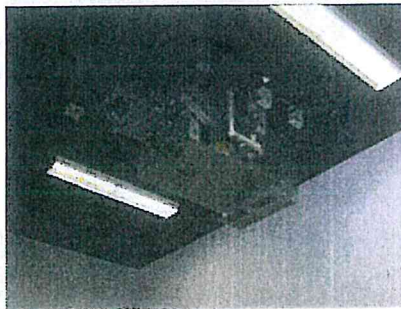
2. The present Heating and Ventilating system consist of hot water finned tube radiation, hot water convectors, unit ventilators, window unit air conditioning units and exhaust systems.
3. The Gymnasium consists of air-handling units with hot water heating coils with fresh air intake louvers and roof mounted exhaust fans for ventilation. This equipment is original to the facility and in fair condition.
4. Lobby heating consists of hot water convectors and unit ventilators.

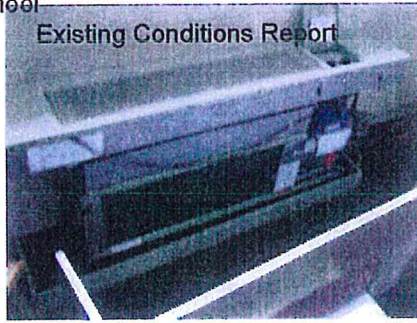
5. Administrative offices heating consist of hot water unit ventilators with air conditioning supplied by individual window units. There have been reported problems with the unit ventilators, such as water leaks, etc. This equipment is original to the facility.

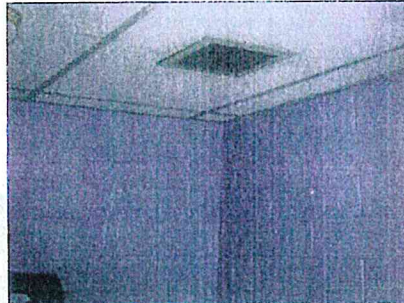
Ventilation for other interior offices consists of a single exhaust grille located at the ceiling.

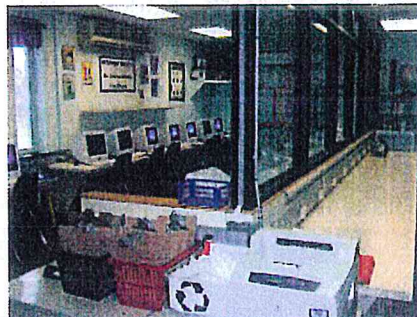
6. General storage heating consists of hot water unit heaters.
7. 1st and 2nd floor Classroom heating and ventilating systems consist of finned tube radiation and general exhaust systems.
8. Media Center consists of roof top mounted air conditioning units with hot water coils for heating. Individual wall mounted ductless split air conditioning systems have been added as the demand for air conditioning has increased.

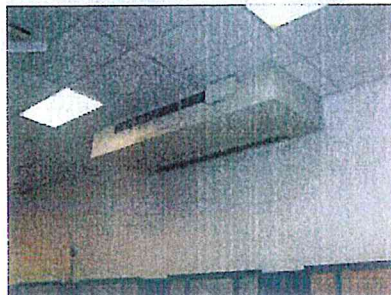
9. Kitchen/Cafeteria heating consists of hot water unit ventilators with fresh air intake louvers. Ventilation consists of roof mounted exhaust fans.

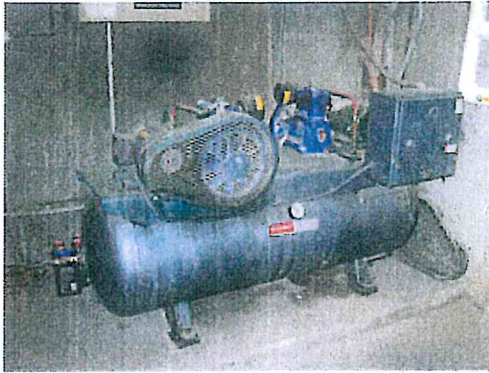
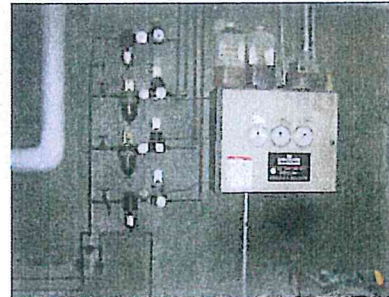
10. The existing temperature controls in the school are pneumatic. The temperature control system air compressor is located near the loading dock and includes a dryer. The building also has an Invensys control system with a graphical interface that is web based. There have been numerous problems reported with the pneumatic control system. During the site visit, air leaks were apparent throughout the building.

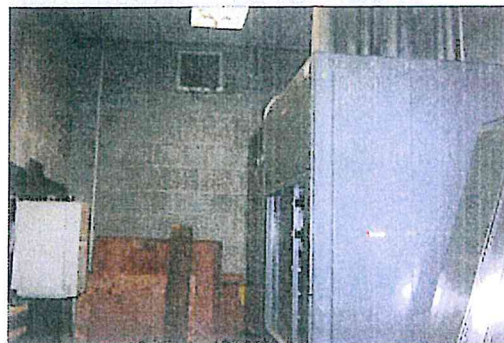
1. The building is served by a single electrical service rated 1,200amperes, 208Y/120volts, 3-phase, 4-wire and is located near the loading dock. This service equipment consists of a utility company transformer, 1,200amp main disconnect switch, distribution section and metering per utility company requirements. The service equipment is original to the building and is in fair condition.

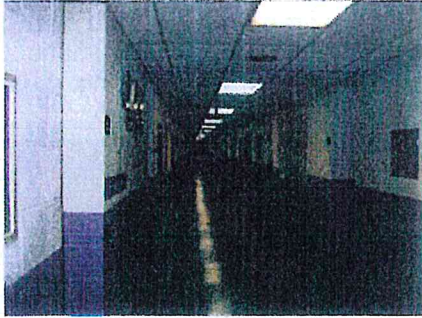
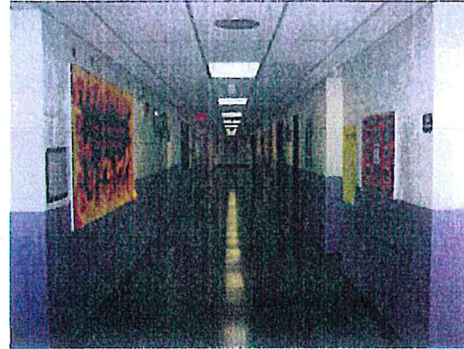
2. There are a number of electrical panels located throughout the facility. These panelboards are original to the facility. The condition of these panelboards is fair. The majority of the panelboards do not have spare circuit breakers available for new circuits to be added, or have space to add new circuit breakers.
3. The lighting throughout the facility consists primarily of recessed acrylic lensed fluorescent fixtures in the classrooms and corridors. The lighting throughout the facility has been upgraded to energy efficient lamps and ballasts through a utility company

rebate program. The lighting is in fair to good condition and the light levels are within recommended levels.

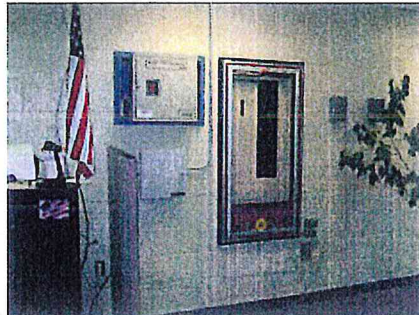
4. Site lighting is limited and consists of pole mounted flood lights. There are no exterior emergency lights that are required to guide people to the public way. The lighting does not appear to be adequate for current codes.
5. The fire alarm system is manufactured by FCI/Silent Knight. The system includes manual pull stations, horn strobes, and ceiling mounted smoke or heat detectors. This system is in good condition, however, additional devices are required to meet current ADA requirements.

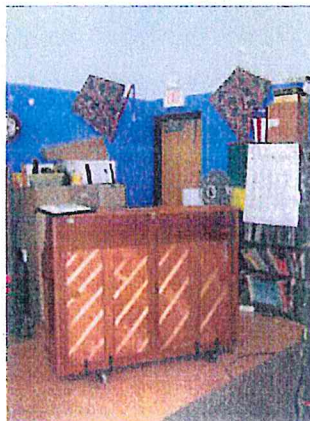
6. The emergency lighting needs are handled by older 2-head emergency lighting units with integral battery packs. These units are in fair condition and are in need of replacement.
7. Exit signs are LED or compact fluorescent type with plastic or metal housings. This equipment is in fair condition.
