Building Conditions Investigations Report

Ralph M. T. Johnson Elementary School:
500 Whittlesey Drive
Bethel, CT

Mechanical and Electrical Systems
Existing Conditions Narrative

Ralph M. T. Johnson School
Bethel, Connecticut
June 27, 2011

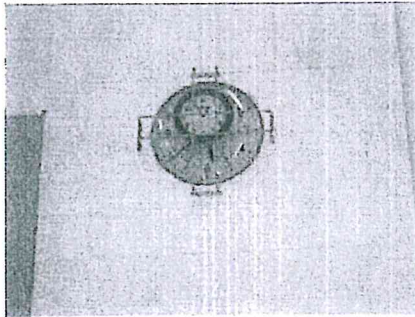
8. The existing master clock system is a Simplex system. This system is not fully operational and individual battery operated clocks have been installed in many locations.
